Manhole Inspection Summary

Manhole # S04CC2005MH

Insp Date: **8/14/06 12:00 AM**

Location Address: **3501 LABYRINTH RD**

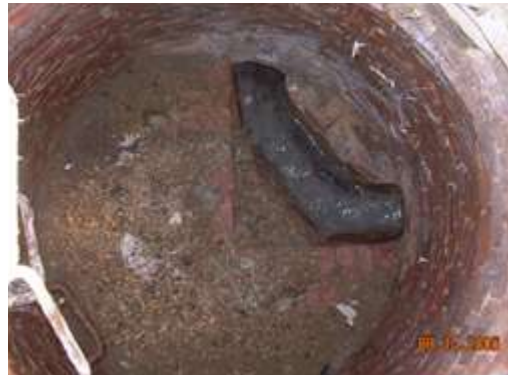
Top View

Infiltration: ☐ None ☒ **Joint** ☐ Cracks ☐ Mortar ☐ Roots ☐ Wall

Steps Count: **4** Missing: **0** ☒ **Corroded**

Adjustment infiltration. Corroded steps.
Bench debris.

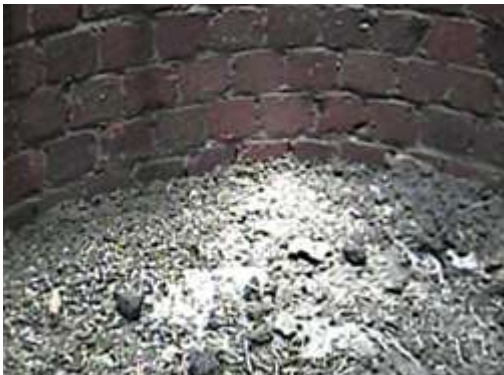
Bench debris

Bench ☒ Exists Material: **Brick** ☐ Parged ☒ **Debris** (not Condition related)

Bench debris.

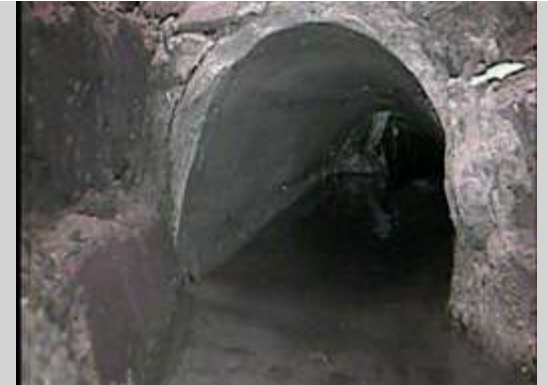
8 in. Circular Gravity Sewer Pipe Out @ 12 O'Clock

Invert Depth: **7.45** (ft.) Flow Characteristics: **Slow**

Infiltration: **None** Pipe Seal Cond: **Unknown**

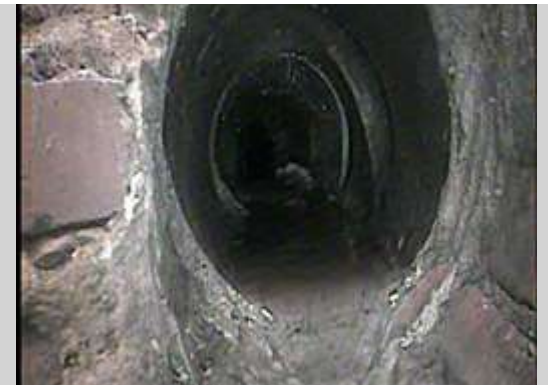
8 in. Circular Gravity Sewer Pipe In @ 3 O'Clock

Invert Depth: **7.15** (ft.) Flow Characteristics: **Slow**

Infiltration: **None** Pipe Seal Cond: **Unknown**
